# Panama Earthquake, 9 October 2026

Independent analysis: data, consequences, root causes, governance gaps and how to build for the next earthquake

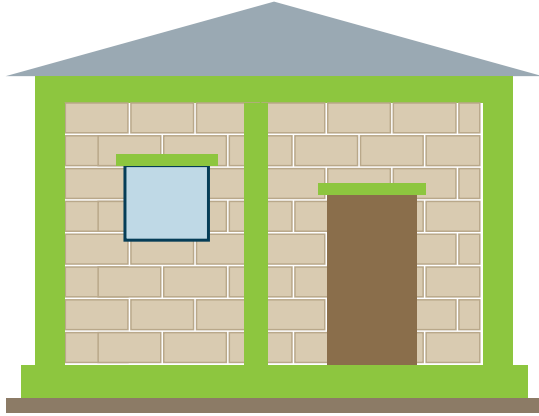
### CORRECT · confined masonry

- 1 Continuous bond beam (ring beam)
- 2 Tie-columns at corners and opening edges
- 3 Continuous foundation beam
- 4 Small, symmetric openings with lintels
- 5 Light, well-anchored roof

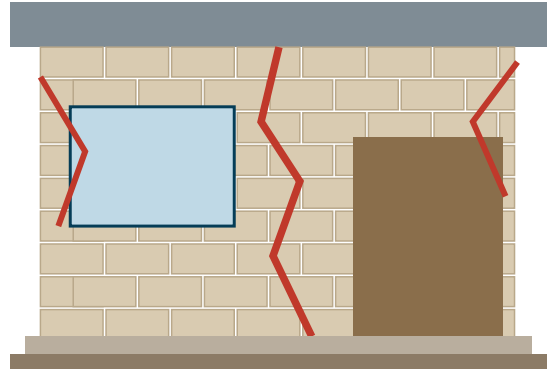
### WRONG · unconfined masonry

- 1 No bond beam: the roof pushes walls apart
- 2 No tie-columns: walls split at corners
- 3 Large openings close to corners
- 4 Hollow block with no reinforcement or grout
- 5 Heavy slab/roof on weak walls

Golden rule: every wall must be "framed" by reinforced concrete — foundation beam below, tie-columns at the ends and at door and window edges, and a bond beam on top, all connected like a box.
