# Panama Earthquake, 9 October 2026

Independent analysis: data, consequences, root causes, governance gaps and how to build for the next earthquake

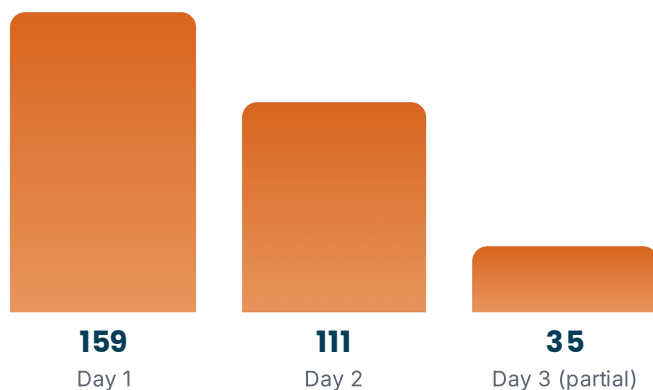
Aftershock sequence (IGC-UP)<sup>[4]</sup>

305 aftershocks in 56 h detected automatically; mean magnitude fell from 4.7 to 4.0. The four aftershocks above M6 occurred in the first 11 hours. The total will grow as analysts review smaller events.

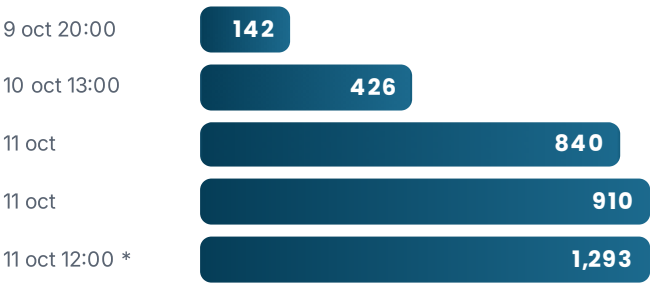
Homes: a number that changed every day

\* 1,293 = homes assessed (not all damaged). Sources: SINAPROC via Wikipedia, Infobae, Telemetro, Retén Chiriquí. <sup>[8,7,6]</sup>
